CUL-35 – 139 Union Street (MA 139)

Town of Holbrook - Culvert Recommendations

April 15, 2022

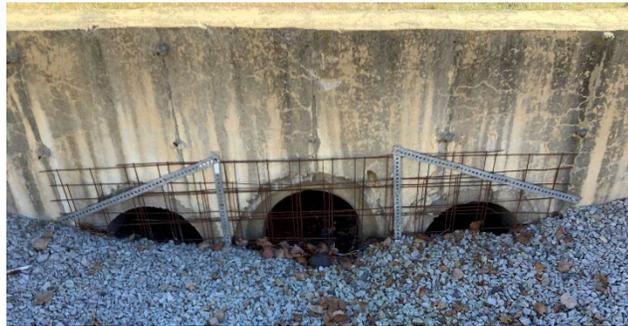
'Good' RCP

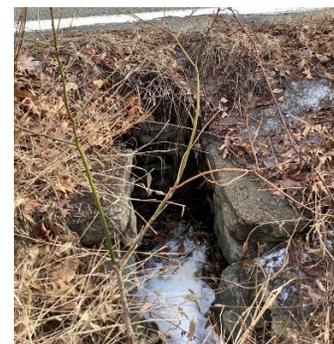
'Failing' Dry Laid Stone

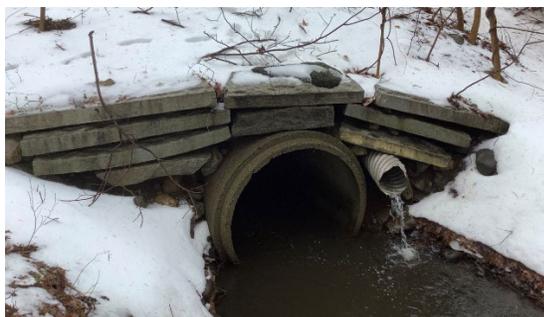
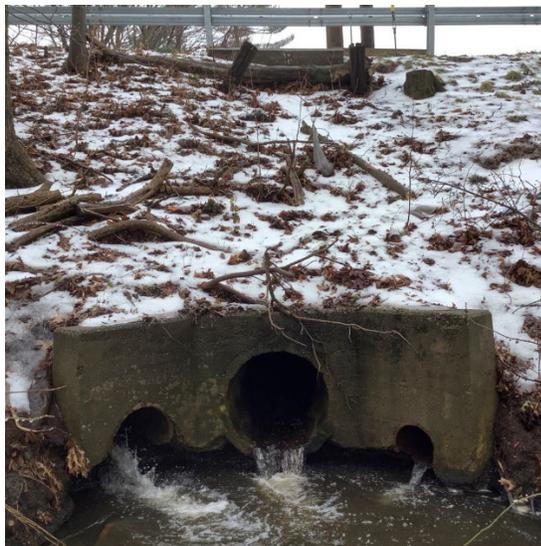
Culvert CUL-35 carries an unnamed tributary to Tumbling Brook from south of Union Street. The inlet is located behind private property and is in fair condition. The outlet is located down the roadway embankment, with the headwall in failing condition. Due to the distance of the headwall to the roadway, this outlet is not considered 'critical', however TEC recommends replacement of the CUL-35 outlet headwall and addition of outlet scour protection to prevent further embankment scour and erosion.

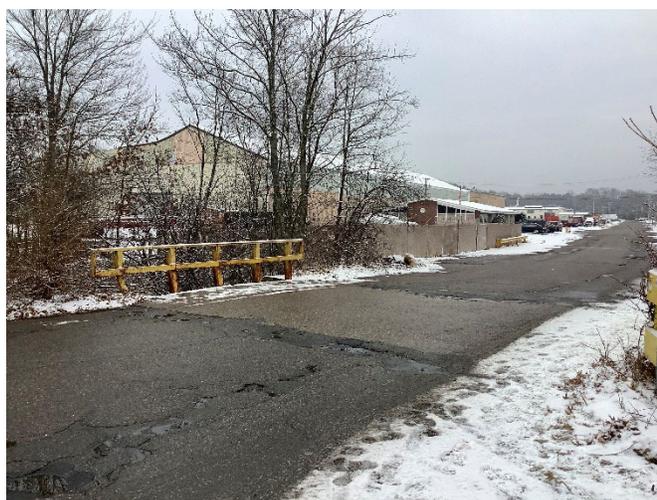
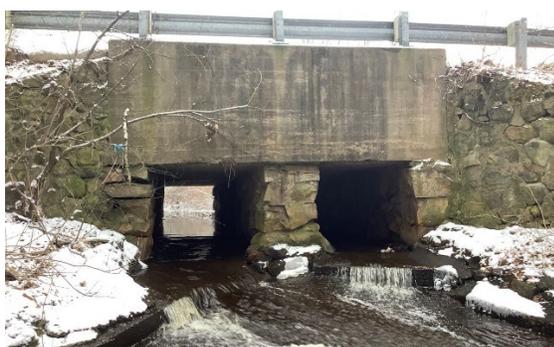
CUL-36 – 2 Mear Road

Structure CUL-36 is an approximately 20' clear span bridge which serves the dead-end Mear Road and the businesses on it. The Cochato River runs beneath it carries water from Lake Holbrook towards Sylvan Lake. The crossing in general is in satisfactory condition, with the only noted deficiency being the damaged and sub-standard traffic safety features. TEC recommends the replacement of existing traffic safety features along the span, and the addition of them along the approach. TEC also recommends a full bridge inspection for this structure.

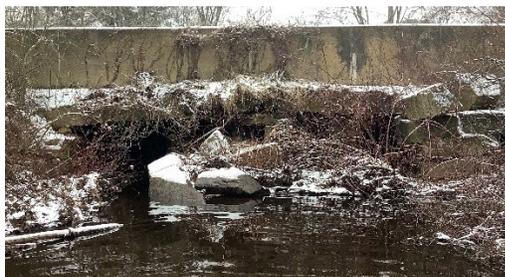
Outlet (Failing): The outlet matches the inlet in both construction and condition. The dry-laid stones are in various states of failure with missing and shifted stones observed. Vegetation was present in the outlet supports as well as embankment, and the granite headers were observed to be offset. The outlet is approximately 225 feet upstream of an MBTA crossing.

Overhead wires and drainage structures were present near the culvert's outlet, with a water line observed over the inlet. Through further research, TEC determined that there is also a gas line passing over the bridge. A concrete wall barrier in satisfactory condition is present on both sides of the roadway. The estimated remaining service life for this culvert is less than 5 years, with immediate action recommended. TEC recommends a full culvert replacement with a three-sided box culvert. The estimated cost of replacement is \$2.5 to \$3.0 million (including utility relocations), depending on the results of the field survey, hydraulic study, and geotechnical investigations.

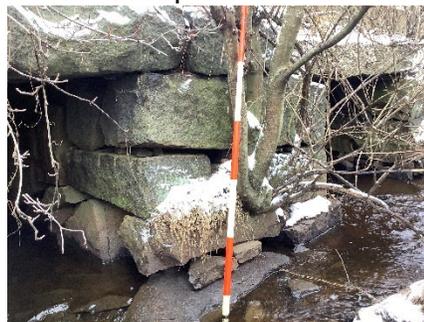
Inlet (Failing): The inlet of the dry-laid stone culvert is actively failing, with large supporting stones observed to have fallen into the river, obstructing the flow. Severe scour and undermining was also observed at all structure elements, contributing to support shifting. The inlet is also heavily vegetated, and the river takes an approximate 90 degree eastern bend 50 feet upstream of the crossing.

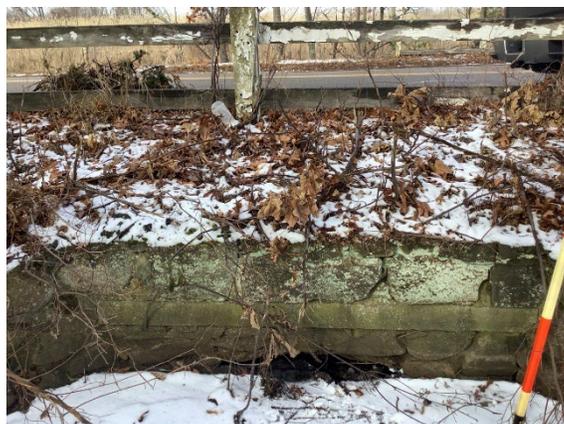
Inlet (Fair): The inlet consisted of a mortared stone head and wingwall which was in fair condition, around a 36 inch CMP. The CMP was in poor condition with rusting and minor separation from the headwall observed. A scour determination was not made due to ice conditions at time of inspection, however no obstruction was felt while probing. Traffic safety features in poor condition were present.

Overhead wires are present over the culvert's inlet, with concrete pillars for traffic safety controls in poor condition at the inlet and failed condition at the outlet. The estimated remaining service life for this culvert is 5 to 10 years. TEC recommends a full culvert replacement with a three-sided box culvert. The estimated cost of replacement is \$700,000 to \$800,000, depending on the results of the field survey, hydraulic study, and geotechnical investigations.

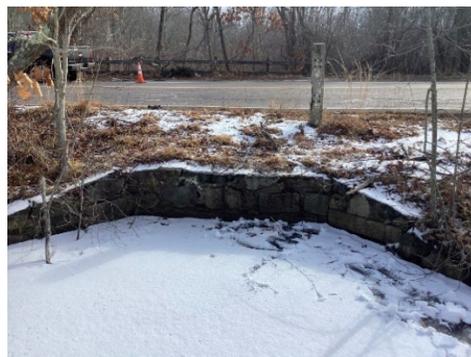
Outlet (Fair): The outlet was completely submerged, but consisted of a mortared stone head and wingwall in fair condition. The CMP was completely submerged, but no obstruction was felt while probing. Pipe condition was not able to be observed, however it is assumed to be of a similar condition to the inlet. Evidence of previous traffic safety features were present, however there is currently no functioning barrier.
