CUL-35 – 139 Union Street (MA 139)

Town of Holbrook - Culvert Recommendations

April 15, 2022

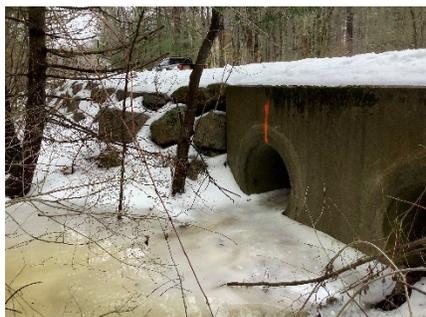
Good

- No to very minor erosion
- No vegetation overgrowth
- No tree or root growth affecting the integrity of the structure

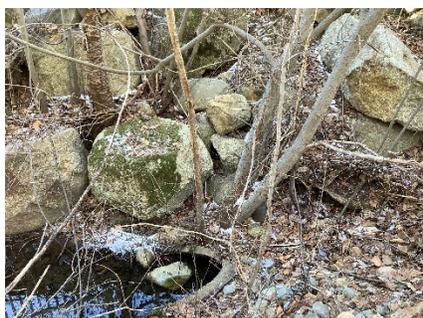
Fair

- Moderate erosion
- Moderate amounts of sediment seeping over and/or through headwall
- Minor to moderate vegetation overgrowth
- Minor tree and/or root growth affecting the integrity of the structure.

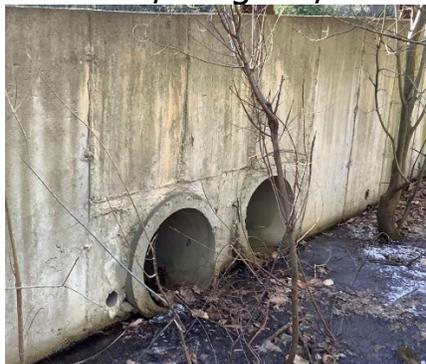
Headwall/Wingwall/Retaining wall Rating Criteria
